## Inspection Report

**Property Address:**  
35 Sample Street  
Ringwood NJ 07456

### **Skyline Home Inspection Services**

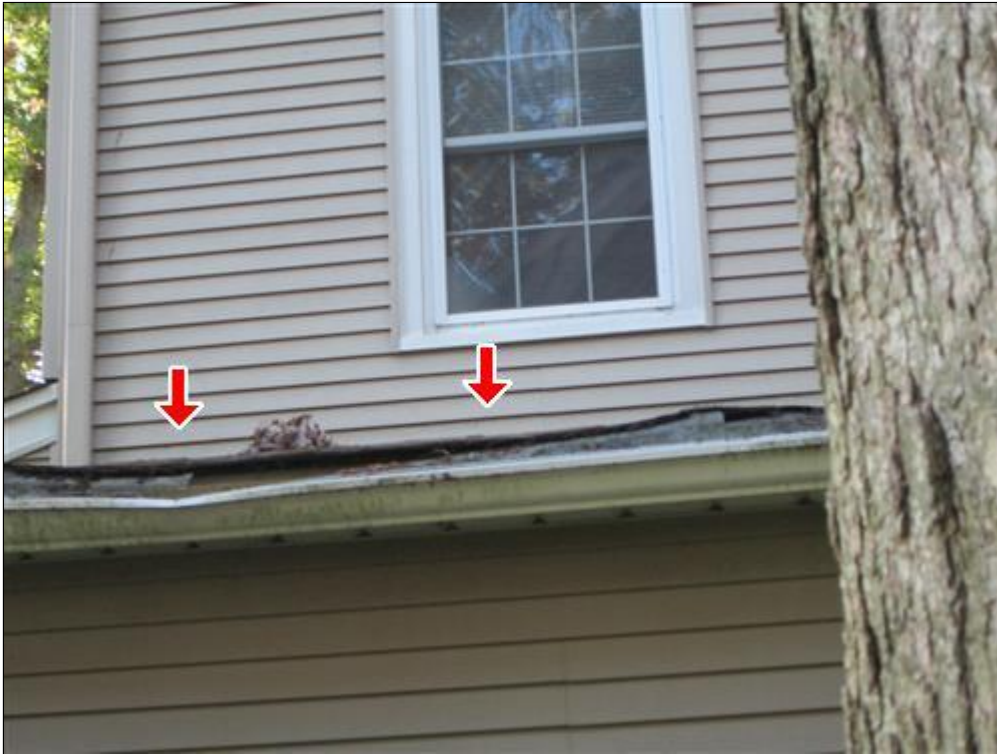
1.0 Picture 1

**1.0** There is damage to the roof at the left side of the home. The sheathing is damaged and the area needs to be repaired by a qualified roofing contractor.

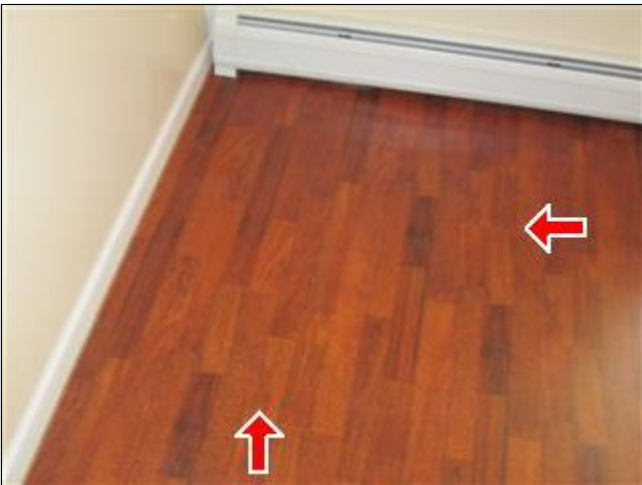
4.2 Picture 1

**4.2 (1)** The flooring is lifted significantly at the right side of the living room. Have the flooring re-secured to prevent it from lifting further.

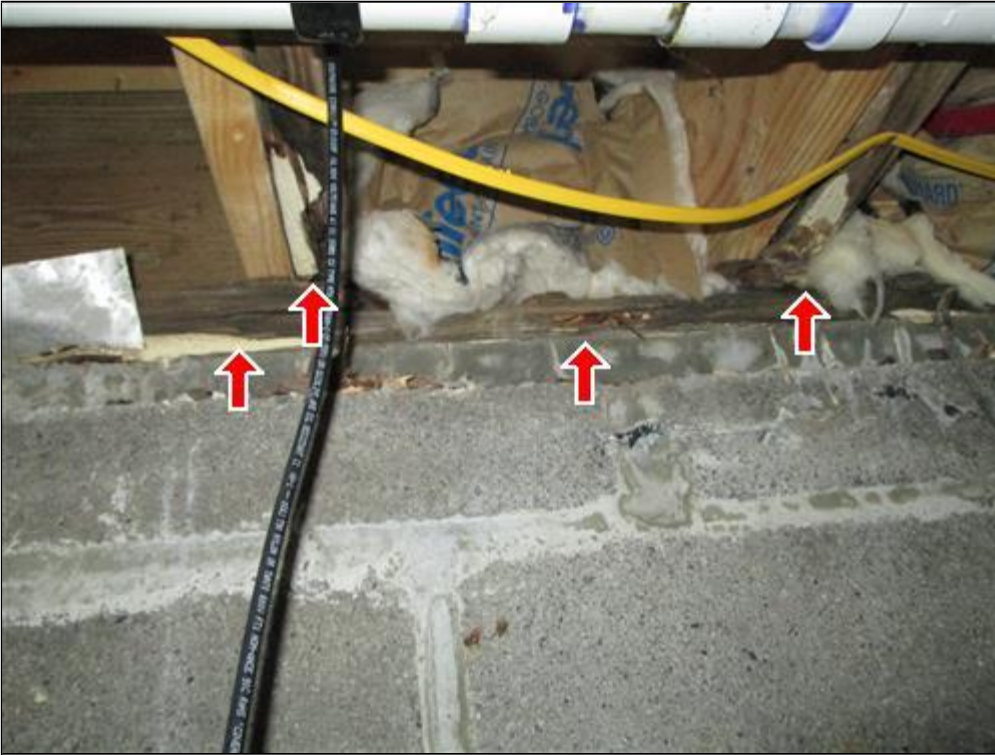
5.3 Picture 1

**5.3** There is damaged wood and floor joists at the rear of the utility room. It appears that this area is where an old staircase was located. It is possible that the damage is from wood destroying insects. There are areas of repaired wood however, there is still a severely damaged sill plate and two improperly re-enforced floor joists. We recommend having these areas repaired to re-enforce the area.

We also recommend asking the homeowner as to the location and treatment of the possible wood destroying insect problem as treatment spray was found in the kitchen cabinet.

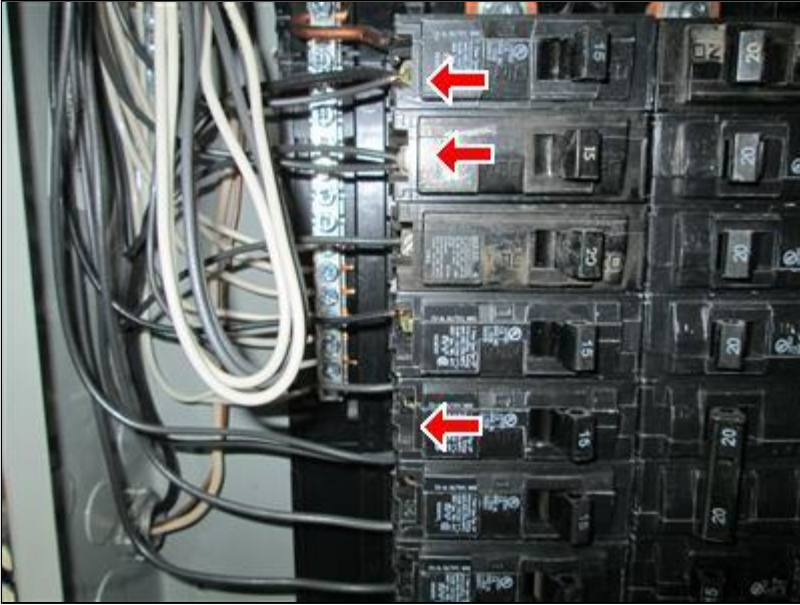
7.1 Picture 1 Right unit Panel

**7.1** There are multiple double wired and a triple wired circuit in both electrical panels of the home. We advise having a qualified electrician correct the wiring as it is incorrect and a potential hazard. Also have all open knockouts closed on the panels.

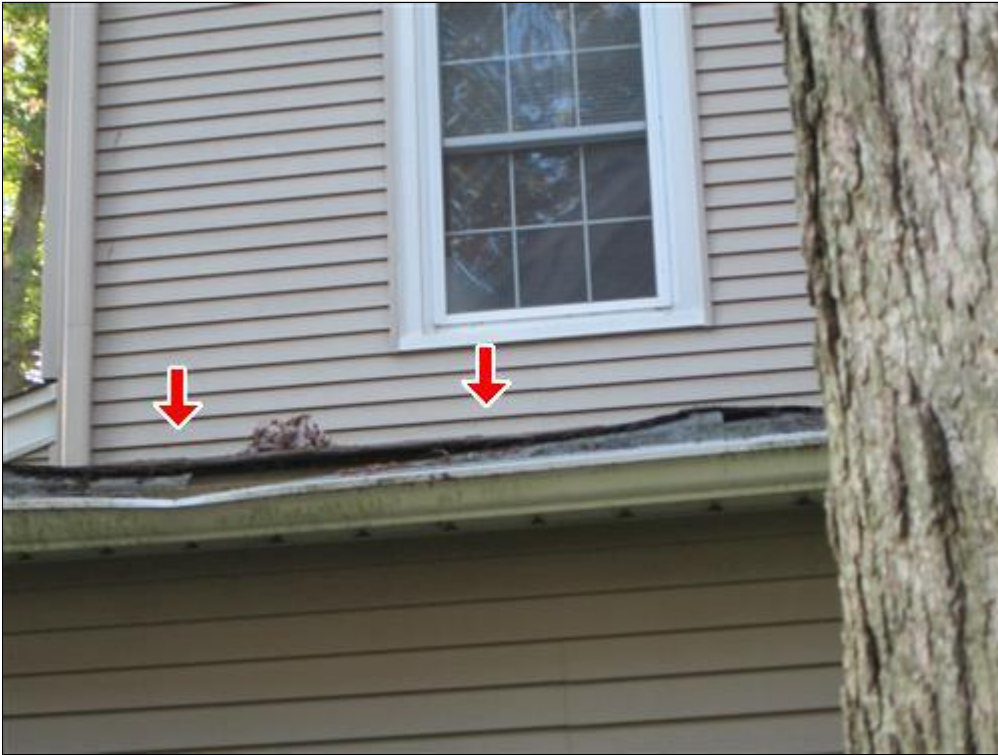
1.0 Picture 1

There is damage to the roof at the left side of the home. The sheathing is damaged and the area needs to be repaired by a qualified roofing contractor.

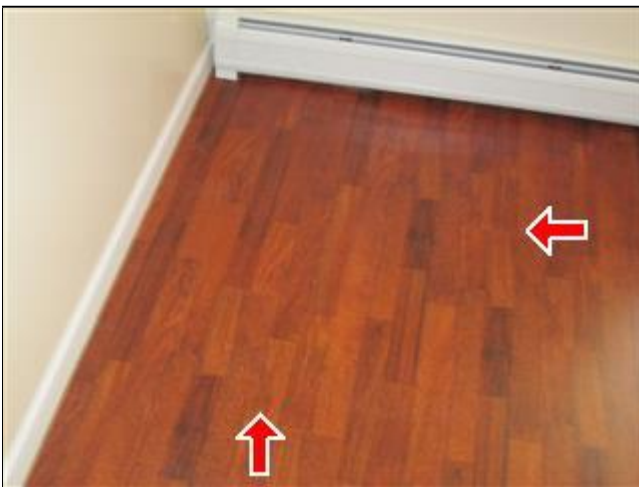
4.2 Picture 1

(1) The flooring is lifted significantly at the right side of the living room. Have the flooring re-secured to prevent it from lifting further.

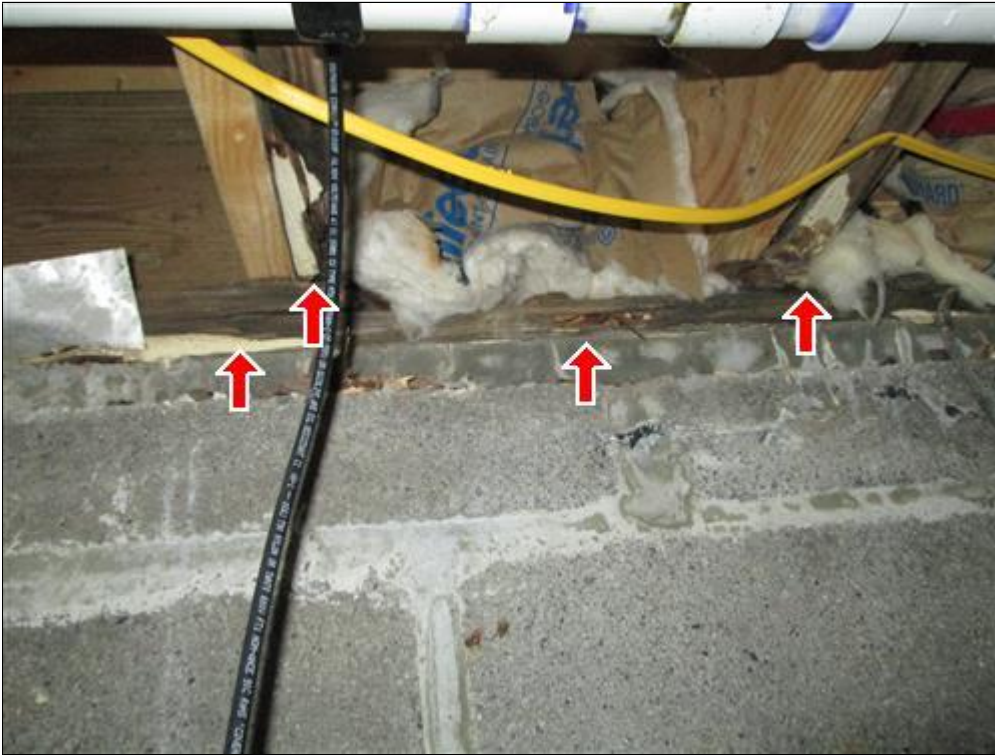
5.3 Picture 1

There is damaged wood and floor joists at the rear of the utility room. It appears that this area is where an old staircase was located. It is possible that the damage is from wood destroying insects. There are areas of repaired wood however, there is still a severely damaged sill plate and two improperly re-enforced floor joists. We recommend having these areas repaired to re-enforce the area.

We also recommend asking the homeowner as to the location and treatment of the possible wood destroying insect problem as treatment spray was found in the kitchen cabinet.

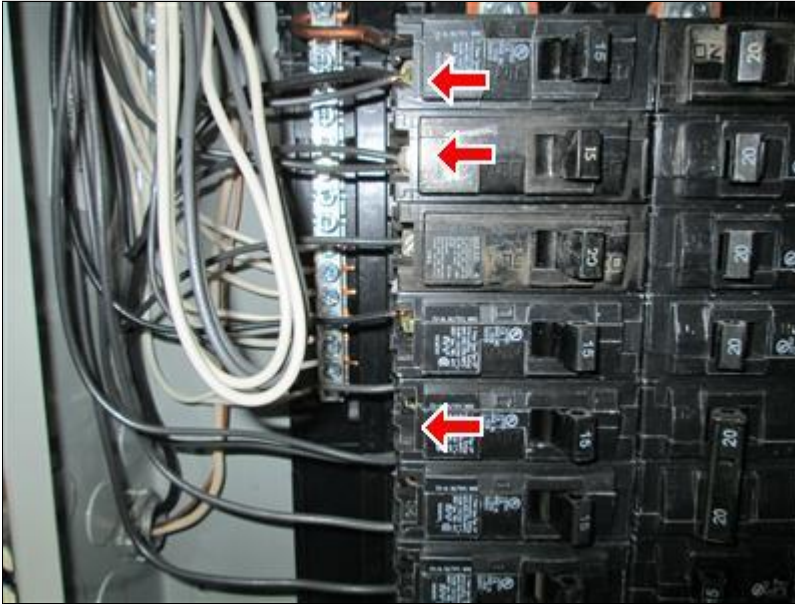
7.1 Picture 1 Right unit Panel

There are multiple double wired and a triple wired circuit in both electrical panels of the home. We advise having a qualified electrician correct the wiring as it is incorrect and a potential hazard. Also have all open knockouts closed on the panels.
